Relocation of a complex and diverse iconographic collection - from an emergency response to a long-term decision and its execution.

Bogdan Filip Zerek, National Library of Poland

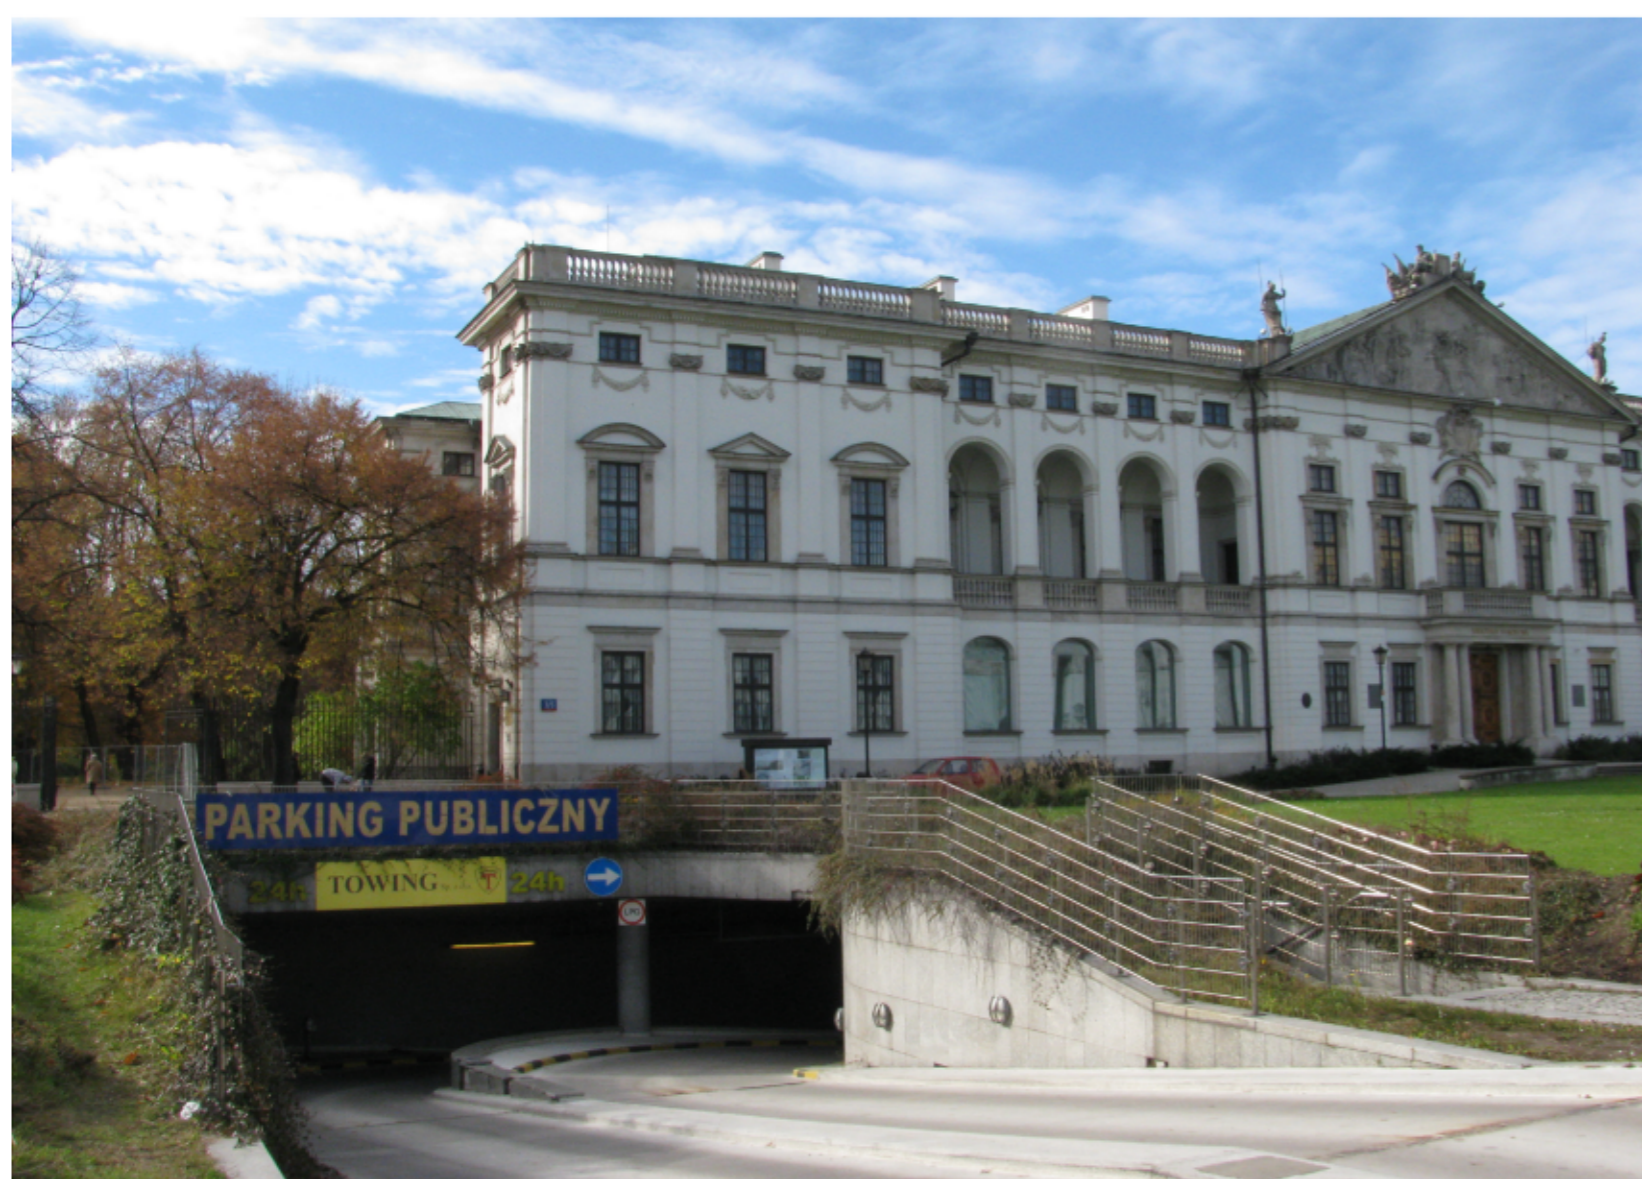
The view of the north east elevation of the Krasinski Palace. The new public parking under the Krasinski Square causes the permanent water activity on the foundations of the Palace. The Palace has two axes of symmetry, except for the roof - there is a walking terrace on the north-east side. That is where the leak may have started.

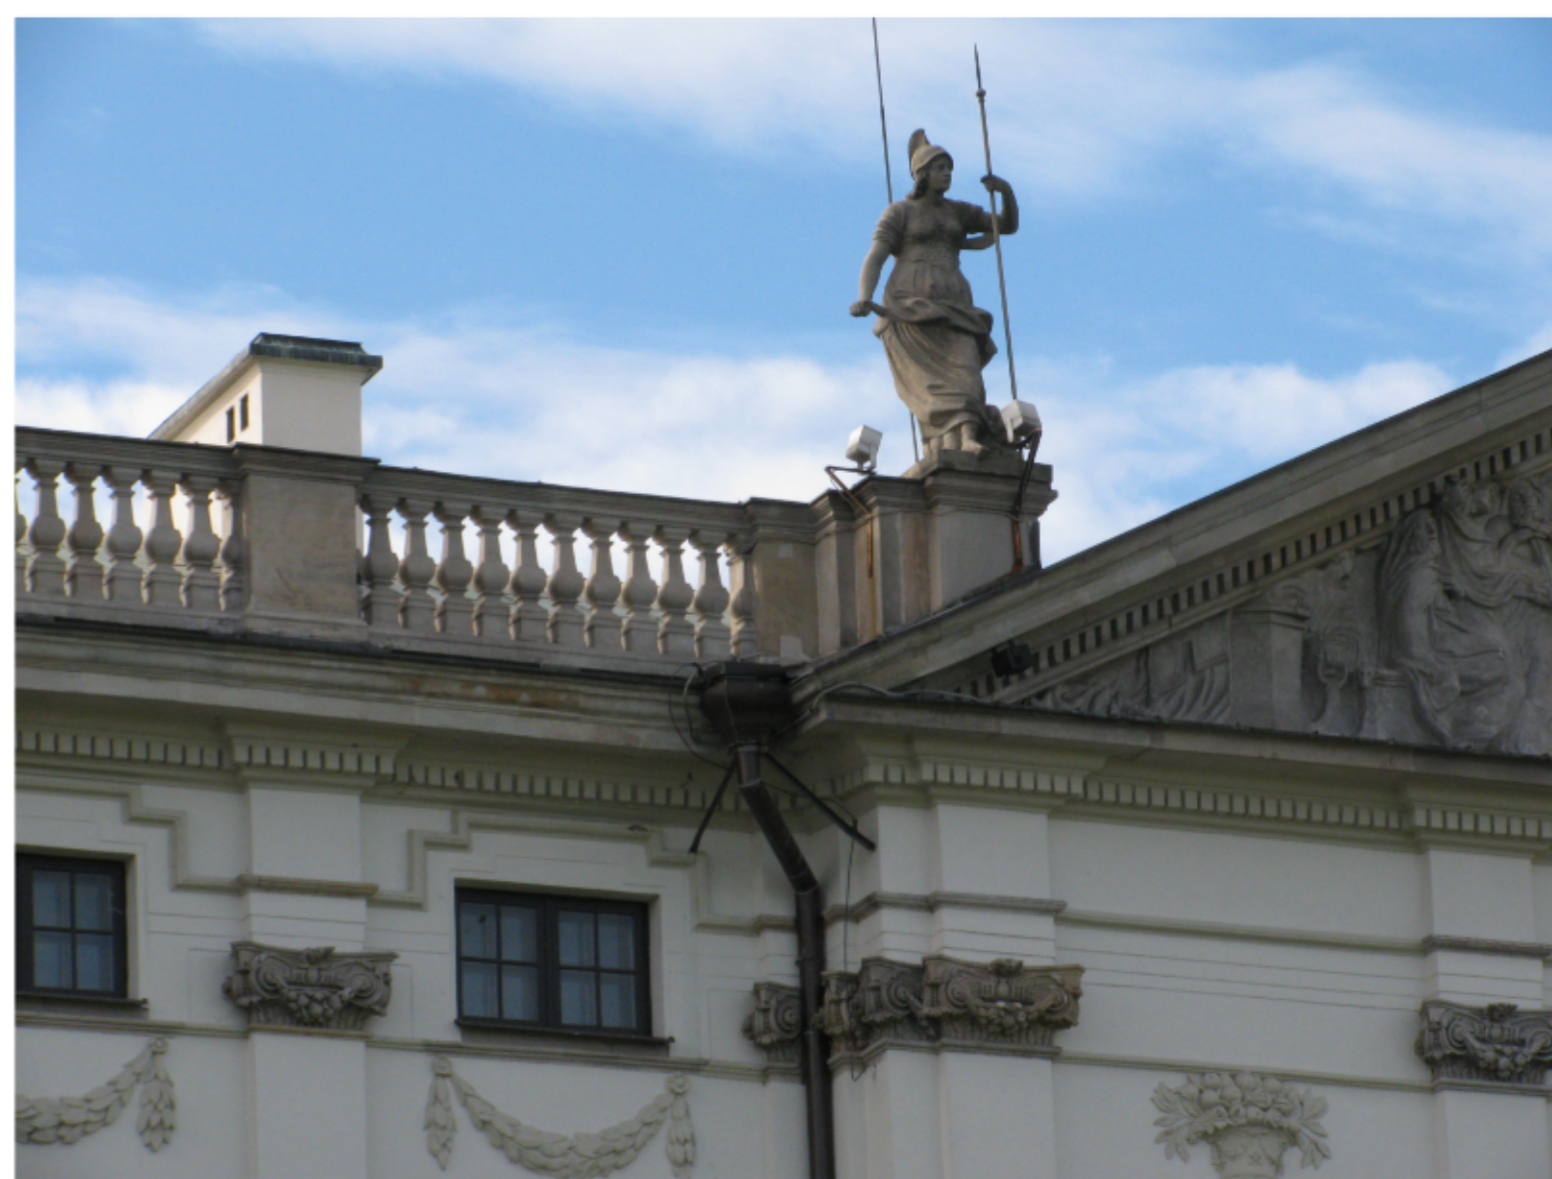
A close-up of the window of the room 218. Behind the drain-pipe there is a wall that showed the water activity. So far the exact reason of the leak has not been discovered yet. Even now in 2013 the wall above the window still "takes the water". The building itself is a monument of heritage and no repairs without the approval of the General Conservator of the Monuments of Heritage can be done.

Monday (of course!) - the first information on water activity on the two walls in the corner of the room 218; immediate local vision and swab sampling of the walls - about two square meters of already drying wet spots and plaster coming off the wall in room 218; photographic documentation of the damaged spots; microbiological impact sampling of the air.

Microbiological growth observed on spots of water activity in the storage room 218.
